PASSAIC RIVER BASIN

GREEN SWAMP NO. I

PHASE I INSPECTION REPORT
NATIONAL DAM SAFETY PROGRAM

NJ 00209

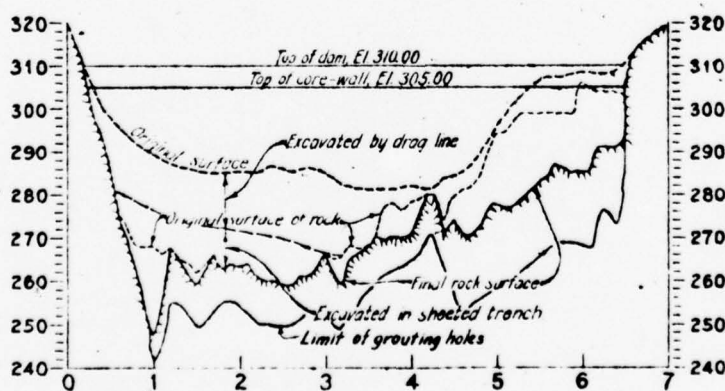
PROFILE
DAM NO 1

7.2.1 Alternatives: The partially settled ground and disturbed riprap between Station 1+50 and Station 3+00 should be checked periodically for any possible further movement.
